**BMW X5: 1GAE635**

**Limited Technical Inspection**

**Degree of wear**

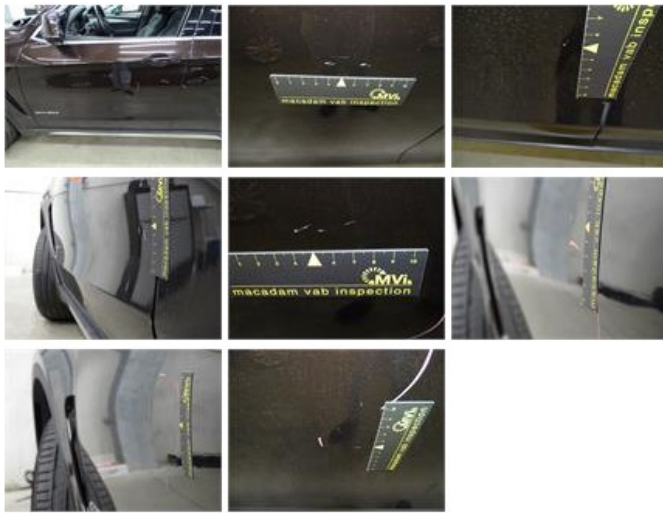
| Door F L, Dent(s) and scratch(es), LI - Repair and paint (complete) | <b>0,00</b> |

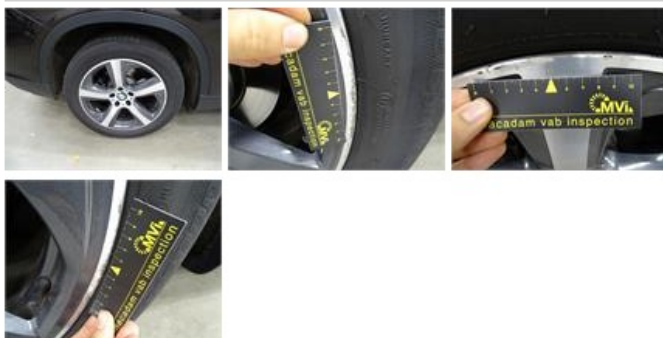
| Alloy rim R R polished, Scratch(es), LI - Repair and paint (complete) | 95,00 |

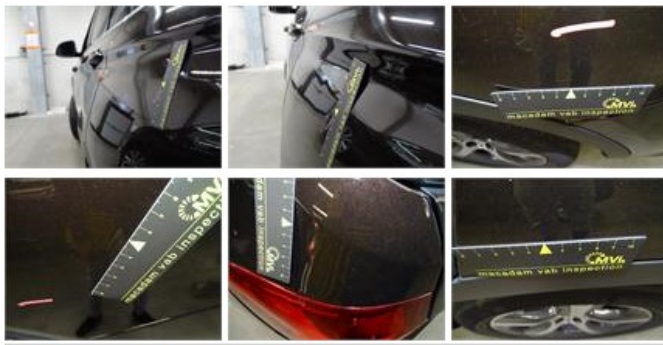
| Wing R L, Dent(s) and scratch(es), LI - Repair and paint (complete) | 0,00 |

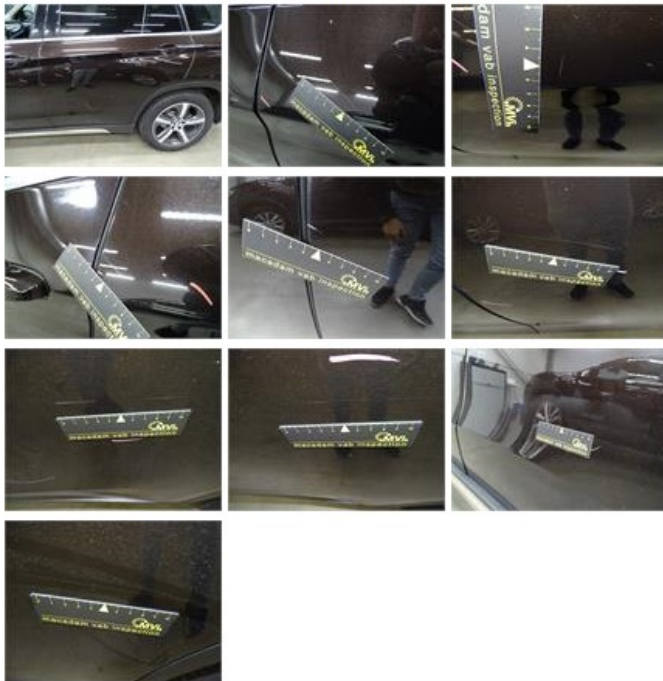
Door R L, Dent(s) and scratch(es), LI - Repair and paint (complete)

382,02

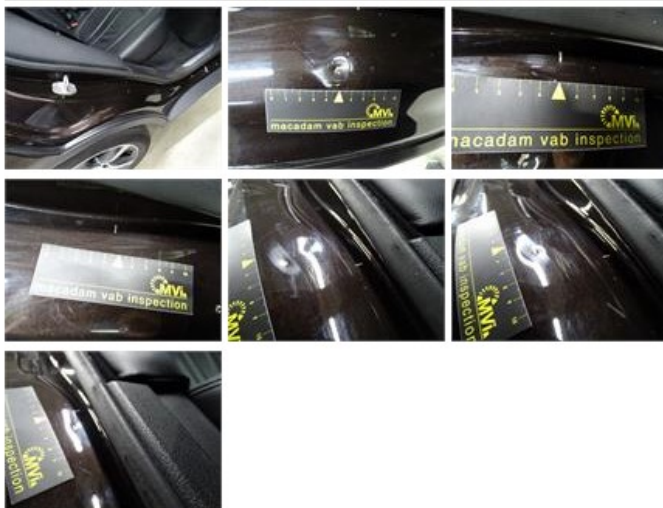
Rocker panel inner R R, Dent(s), LI - Repair and paint (complete)

115,56

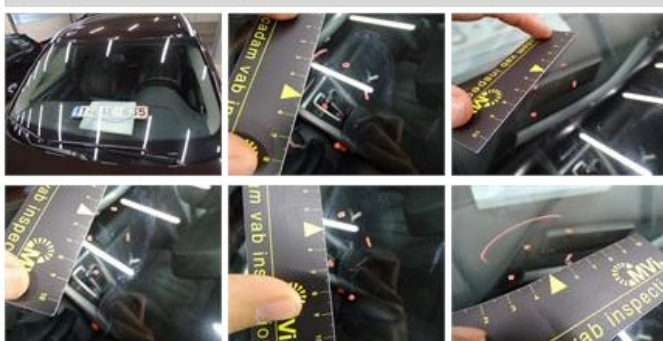
Windscreen, Repaired, Acceptable
