BMW 3: 1JVK851

| Vinnumber: | WBA3K11070F838225 | Versionname: | |

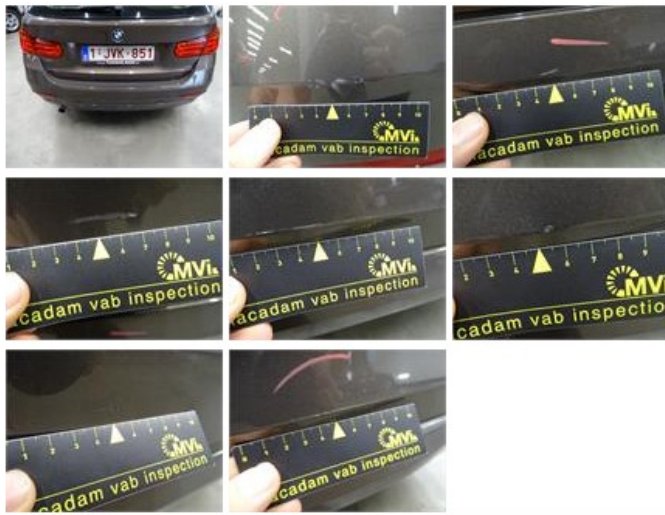
| Bumper R, Scratch(es), LI - Repair and paint (complete) | 211,80 |

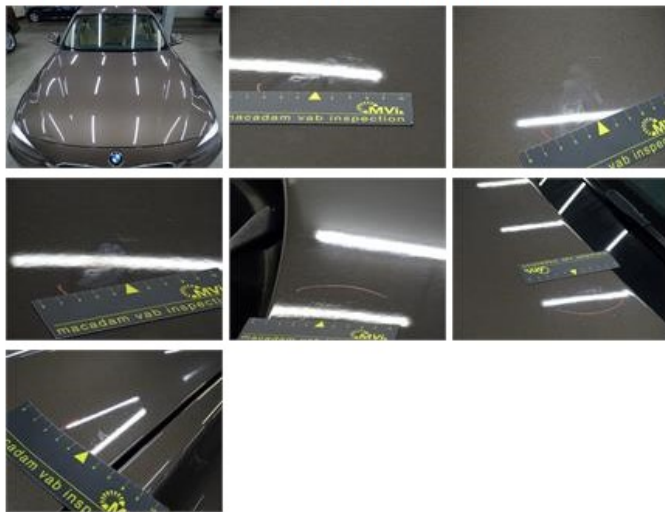
| Bonnet, Chemical polution, LI - Repair and paint (complete) | 290,08 |

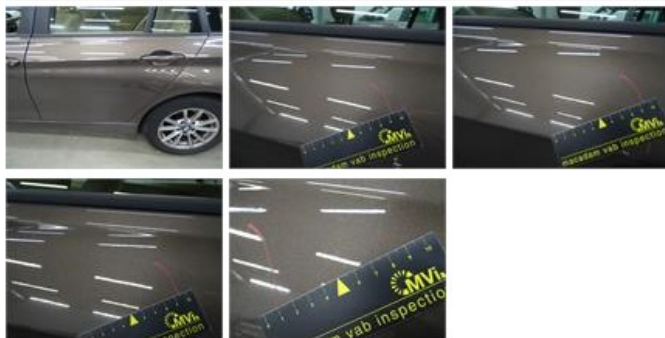
| Door R L, Bad repair, Acceptable | 0,00 |

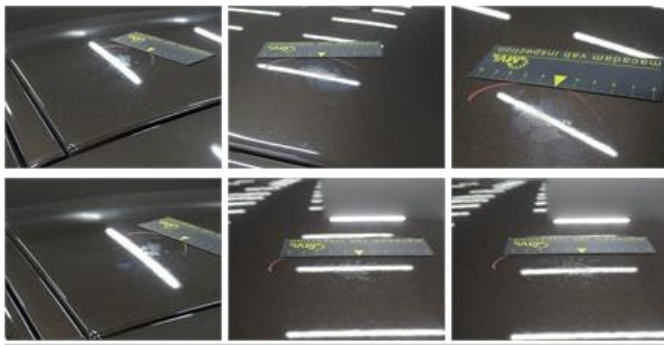
| Roof, Chemical polution, LI - Repair and paint (complete) | 481,50 |
