# PEUGEOT 308 SW: 1LCD997

| Vinnumber: | VF3LC9HPAFS106813 | Versionname: | 1.6 HDI 68KW ACTIVE |

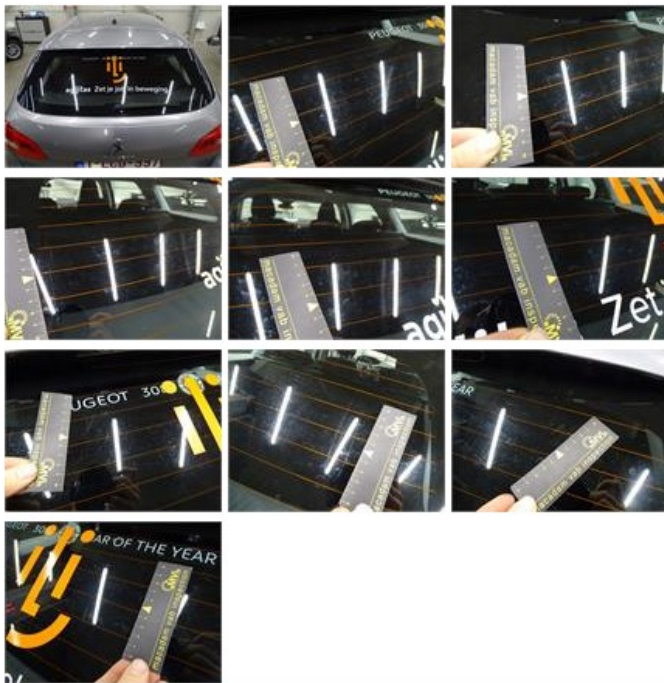
| Rear window, Scratch(es), E - Replace | 370,00 |

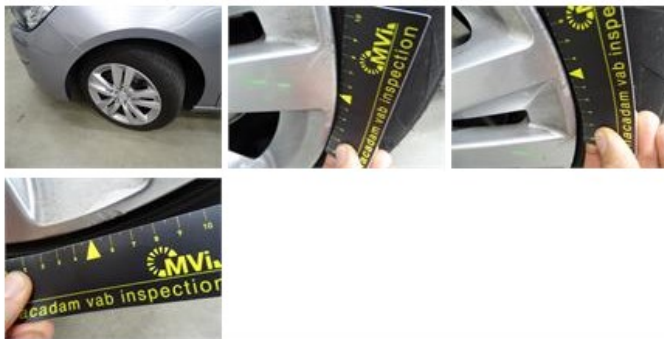
Alloy rim F L, Scratch(es), LI - Repair and paint (complete)

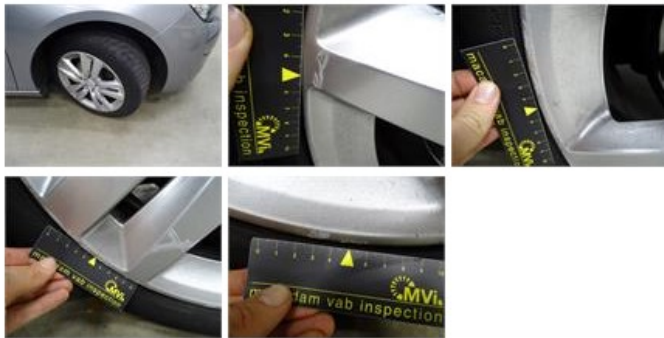
Alloy rim F R, Scratch(es), LI - Repair and paint (complete)

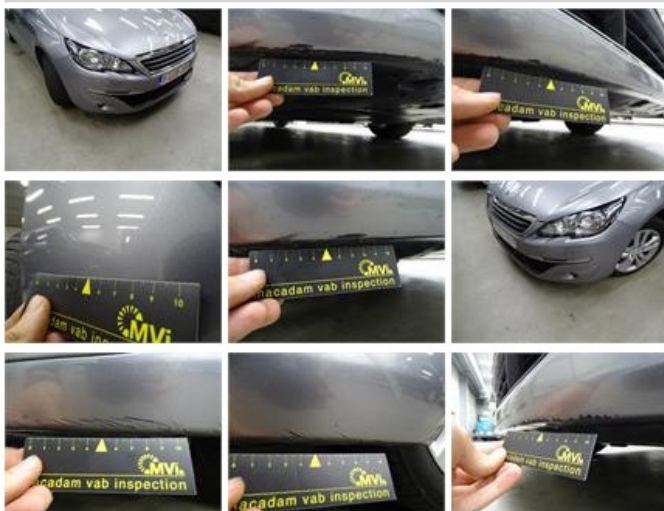
Bumper F, Scratch(es), LI - Repair and paint (complete)

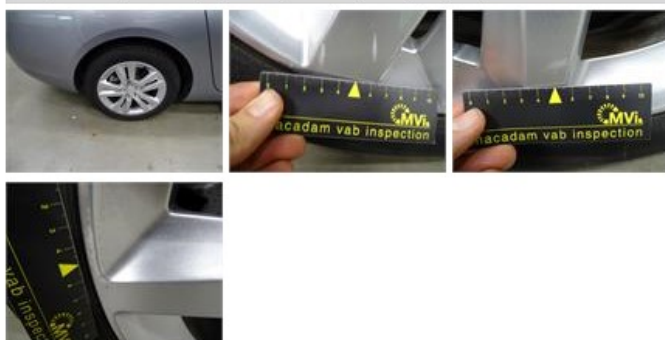
Alloy rim R R, Scratch(es), LI - Repair and paint (complete)

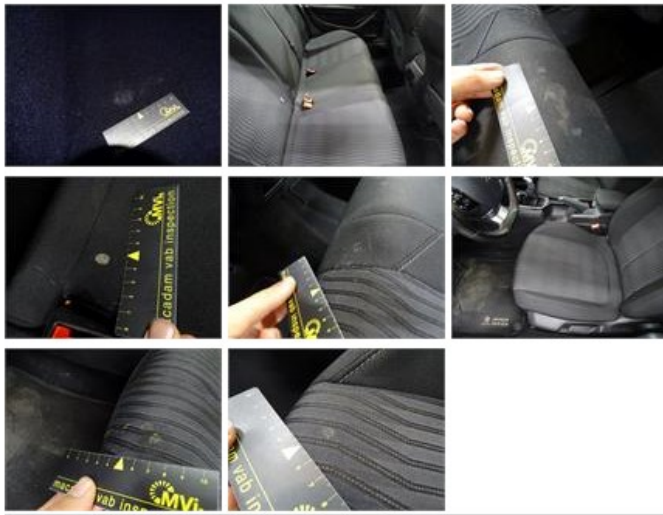
Interior, Dirty, Cleaning
