**VOLVO XC60: 1KVZ870**

**Limited Technical Inspection**

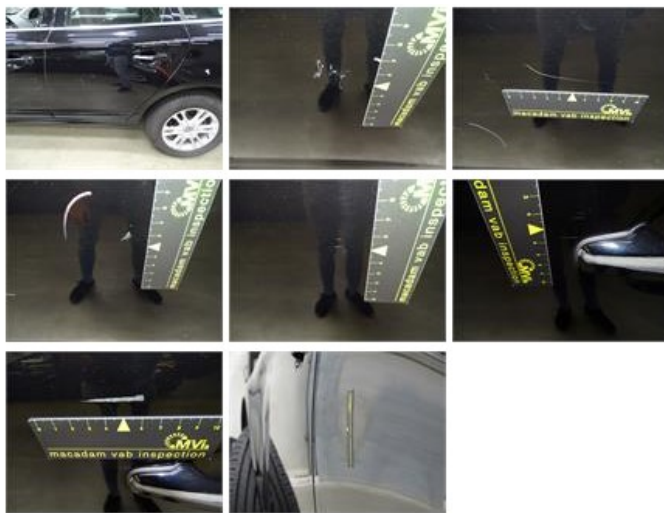
| Door R L, Dent(s) and scratch(es), LI - Repair and paint (complete) | <b>382,02</b> |

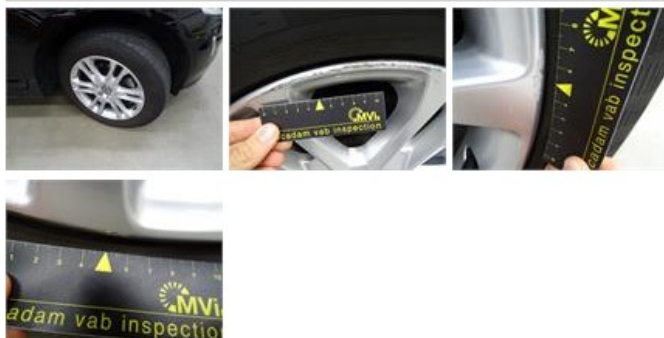
Alloy rim F R, Scratch(es), LI - Repair and paint (complete)

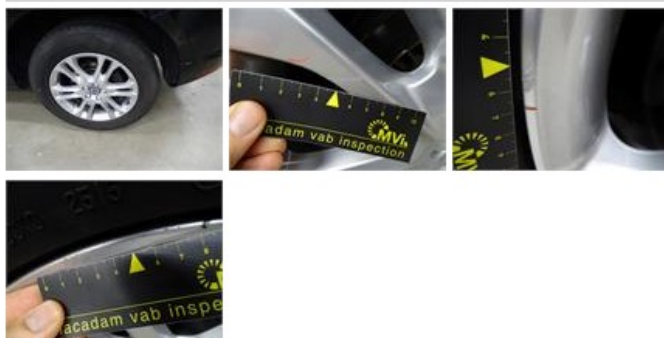
Alloy rim R L, Scratch(es), LI - Repair and paint (complete)

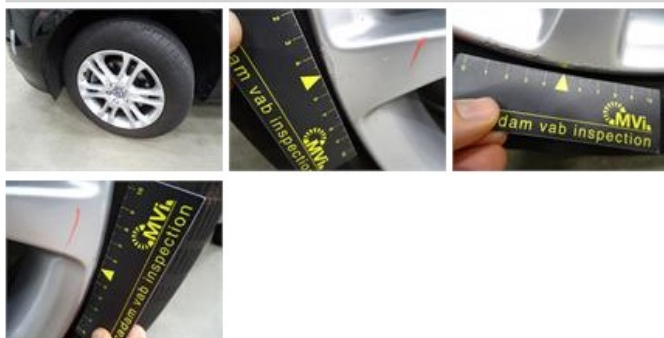
Alloy rim F L, Scratch(es), LI - Repair and paint (complete)

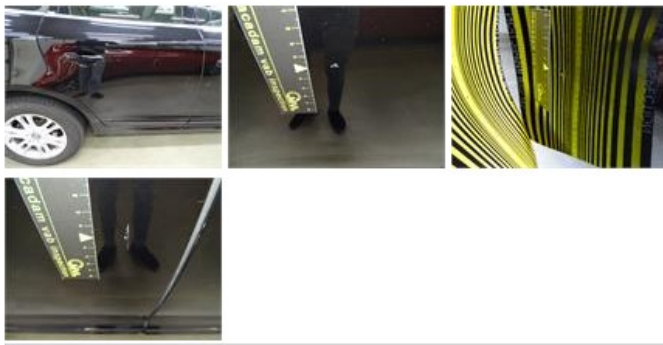
Door R R, Dent(s) and scratch(es), LI - Repair and paint (complete)

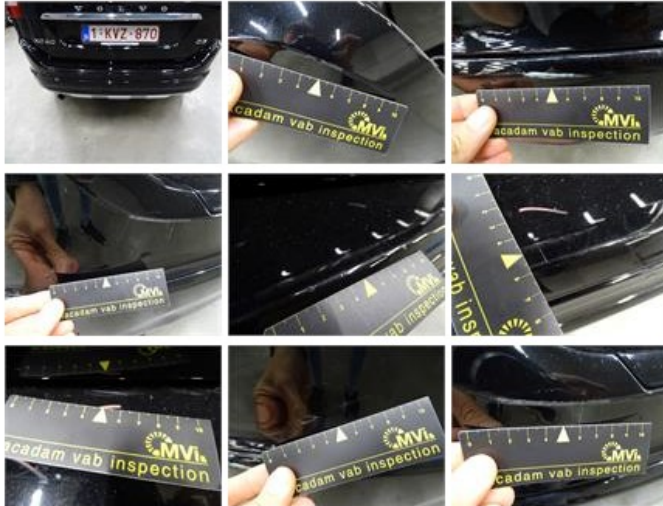
Bumper R, Scratch(es), LI - Repair and paint (complete)

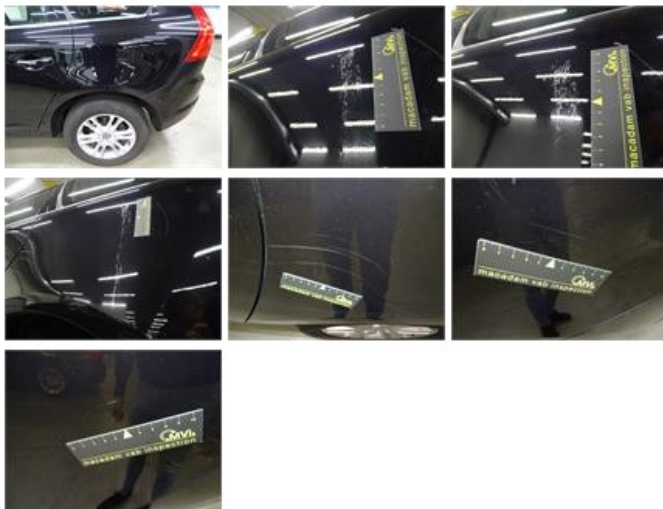
Wing R L, Chemical polution, LI - Repair and paint (complete)

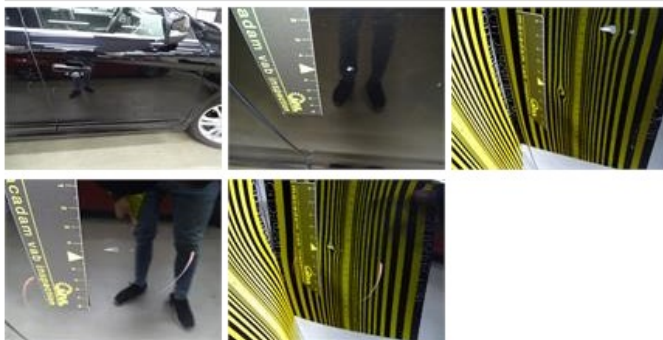
Door F R, Dent(s) and scratch(es), LI - Repair and paint (complete)

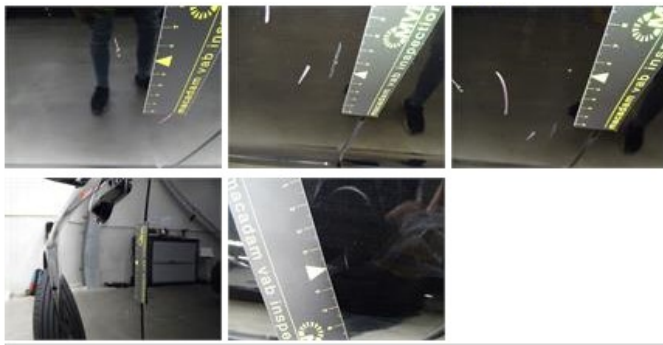
Door F L, Dent(s) and scratch(es), LI - Repair and paint (complete)

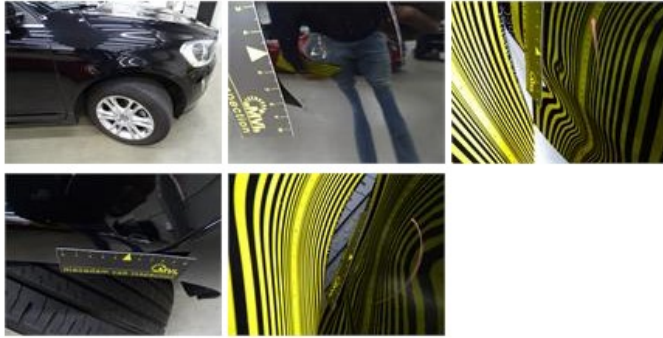
Wing F R, Dent(s) and scratch(es), LI - Repair and paint (complete)
