LU Volkswagen Tiguan: MK4631

Limited Technical Inspection

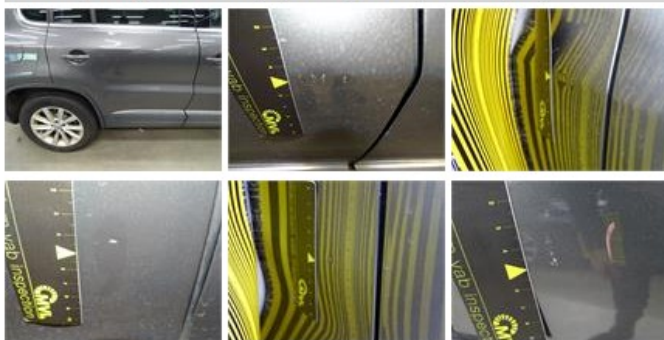
Door R R, Dent(s) and scratch(es), LI - Repair and paint (complete)

318,35

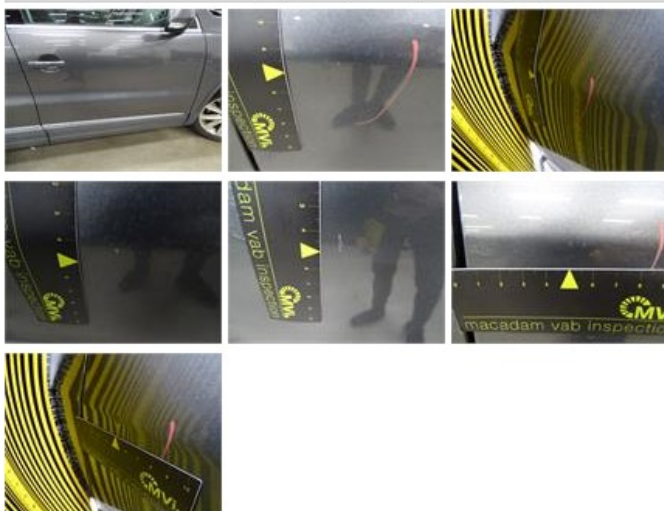
Door F R, Dent(s) and scratch(es), LI - Repair and paint (complete)

318,35
