**RENAULT ESPACE: 1LRS642**

| Vinnumber: | <b>VF1RFC00153919971</b> | Versionname: | <b>1.6 DCI 130 ENERGY INTENS</b> |

**Limited Technical Inspection**

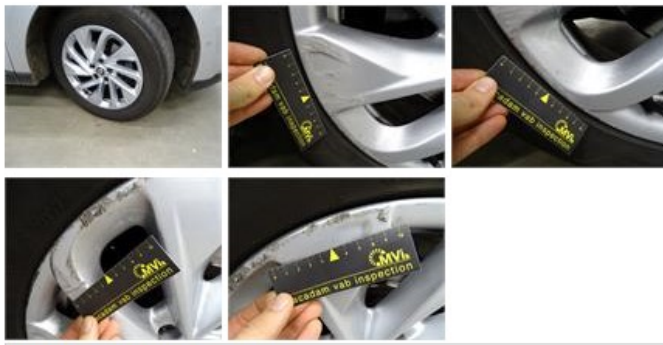
| Alloy rim F R, Scratch(es), LI - Repair and paint (complete) | <b>95,00</b> |

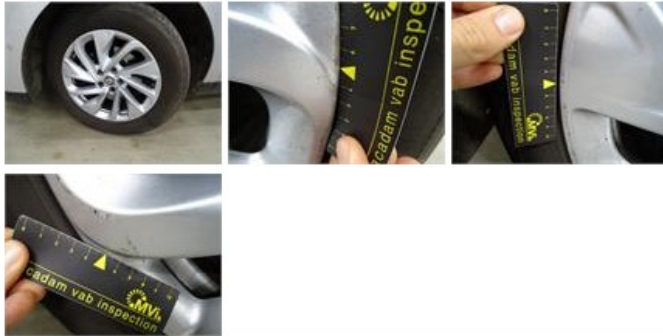
| Alloy rim F L, Scratch(es), LI - Repair and paint (complete) | 95,00 |

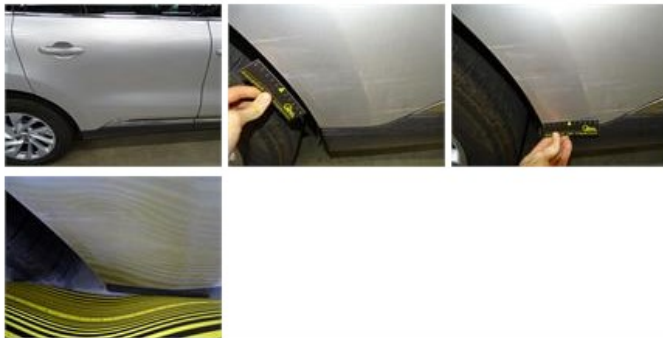
| Door R R, Dent(s) and scratch(es), LI - Repair and paint (complete) | 382,02 |

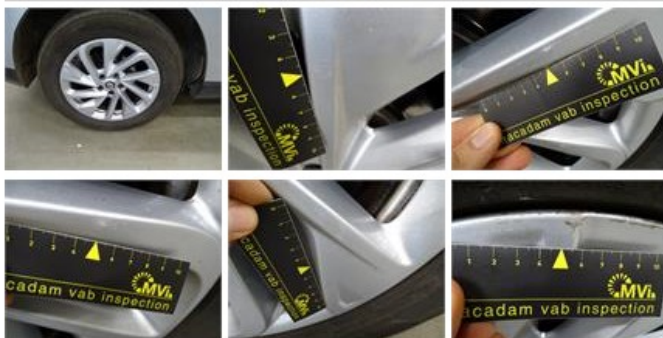
| Alloy rim R R, Scratch(es), LI - Repair and paint (complete) | 95,00 |

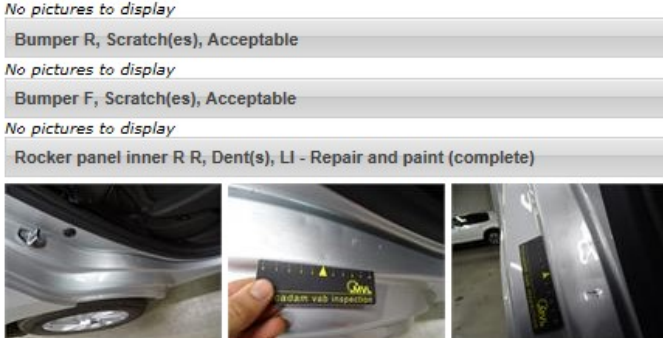
| Rocker panel inner R R, Dent(s), LI - Repair and paint (complete) | 115,56 |

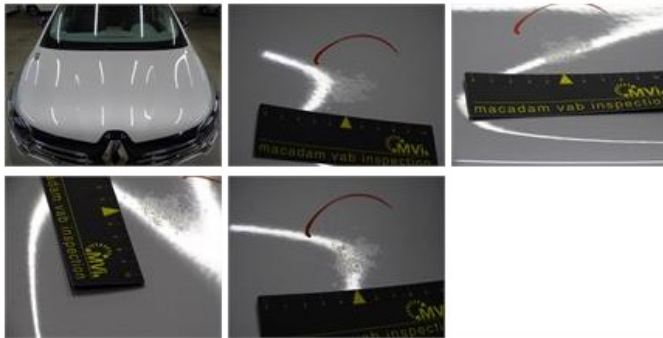
| Bonnet, Chemical polution, LI - Repair and paint (complete) | 348,09 |

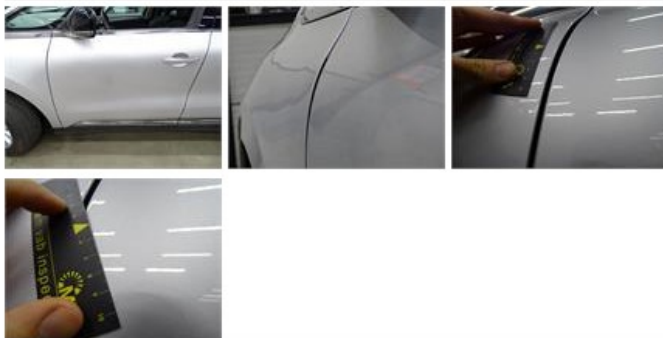
| Door F L, Bad repair, Acceptable | 0,00 |
