**VOLKSWAGEN GOLF VII: 1LNB523**

**Limited Technical Inspection**

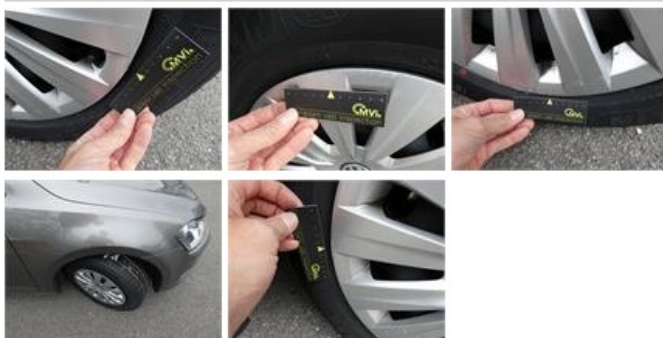
| Wheel cover F R, Scratch(es), E - Replace | 30,00 |
