#### BMW 1 HATCH: 1LHE492

| Vinnumber: | WBA1V910805B19362 | Versionname: | 1.5 116D EFFICIENTDYNAMICS EDIT. (85KW) |

#### Limited Technical Inspection

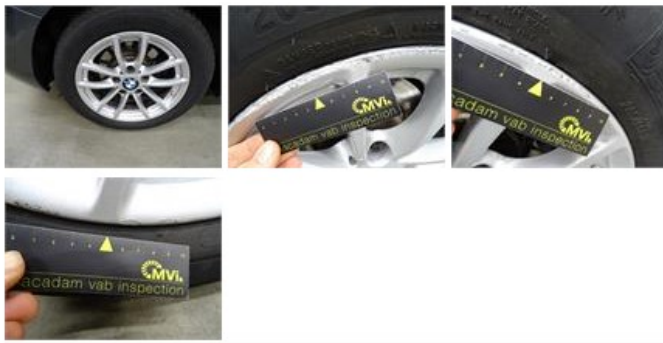
| Alloy rim R R, Scratch(es), LI - Repair and paint (complete) | 95,00 |

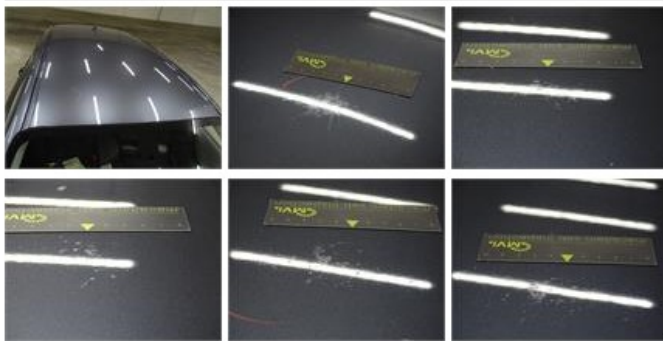
Roof, Chemical polution, LI - Repair and paint (complete)

481,50

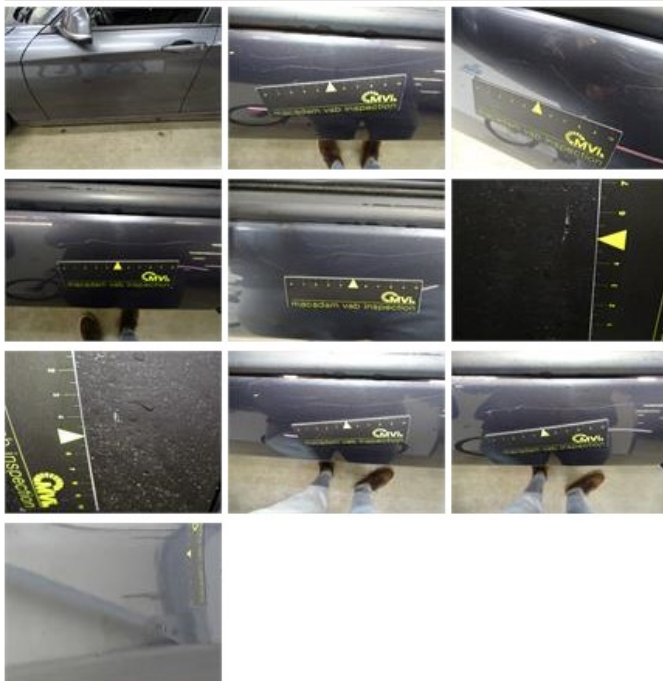
Door F L, Dent(s) and scratch(es), LI - Repair and paint (complete)

318,35

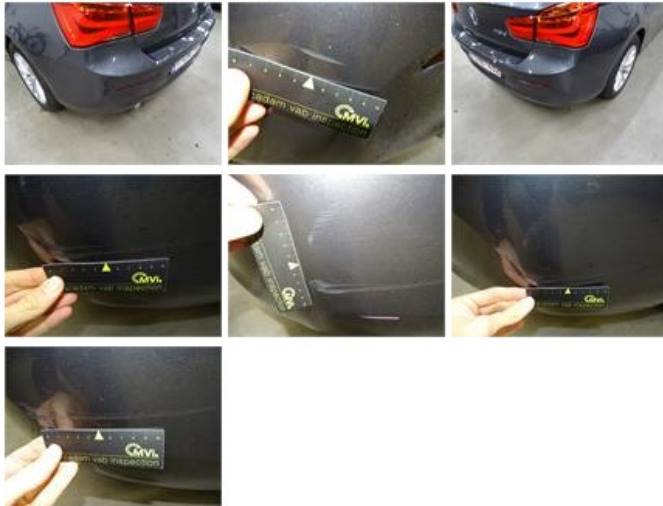
| Bumper R, Scratch(es), LI - Repair and paint (complete) | 211,80 |
