FORD Fiesta: 1HEJ598

| Vinnumber: | WF0DXXGAKDEU88874 | Versionname: | FIESTA BER EcoBoost Titanium S/S 125PK |

Limited Technical Inspection

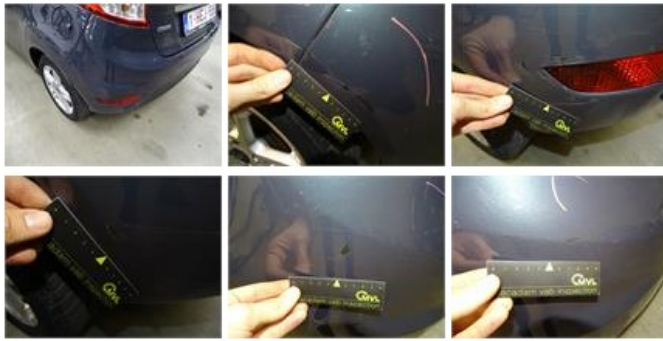
Bumper R, Scratch(es), LI - Repair and paint (complete)

169,44

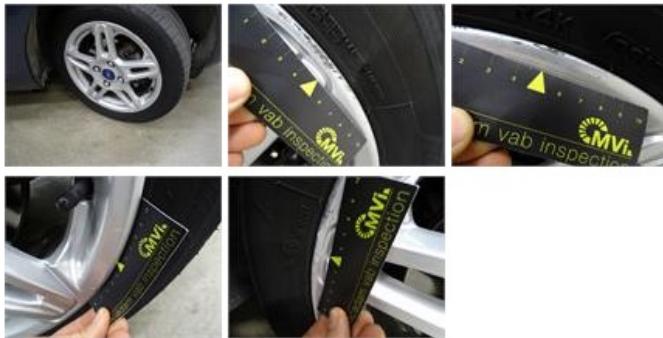
Alloy rim F R, Scratch(es), LI - Repair and paint (complete)

95,00

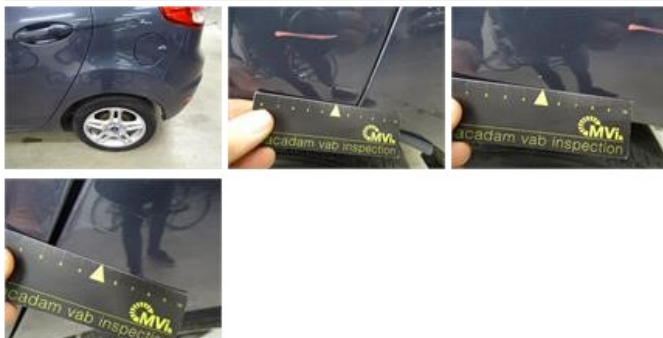
Wing R L, Scratch(es), LI - Repair and paint (complete)

246,56

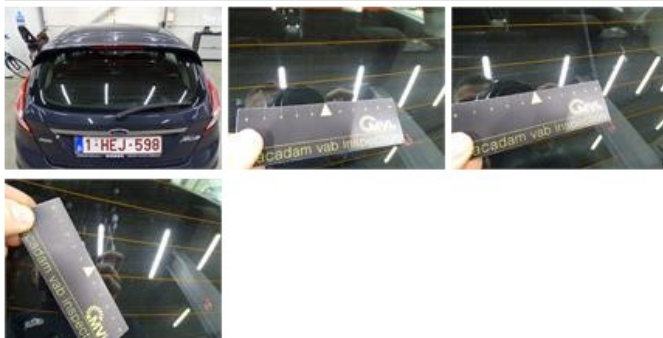
Rear window, Scratch(es), Acceptable

0,00

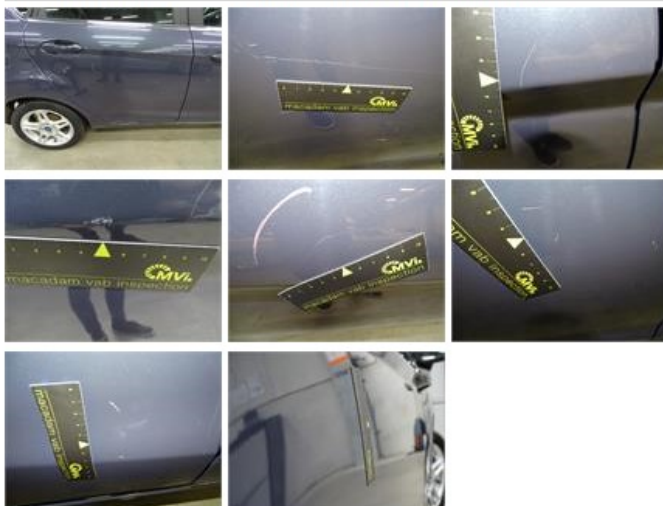
Door R R, Dent(s) and scratch(es), LI - Repair and paint (complete)

254,68

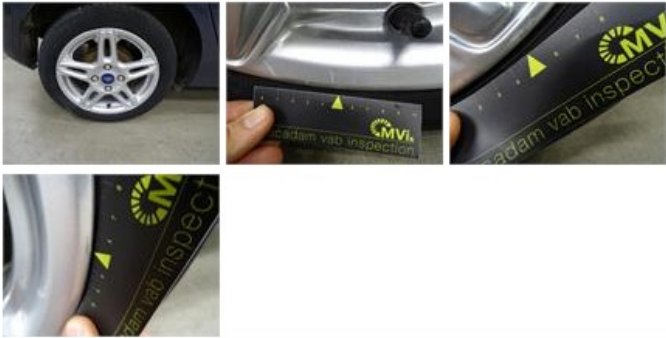
| Alloy rim R R, Scratch(es), LI - Repair and paint (complete) | 95,00 |

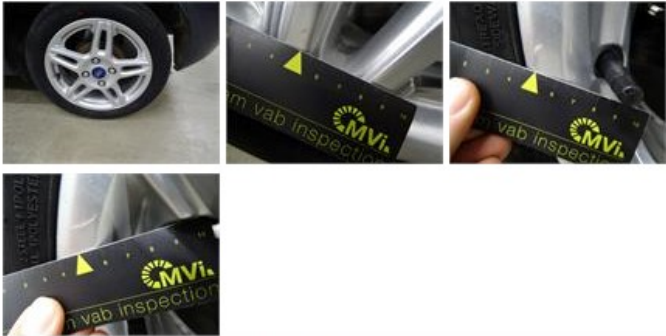
| Alloy rim R L, Scratch(es), LI - Repair and paint (complete) | 95,00 |

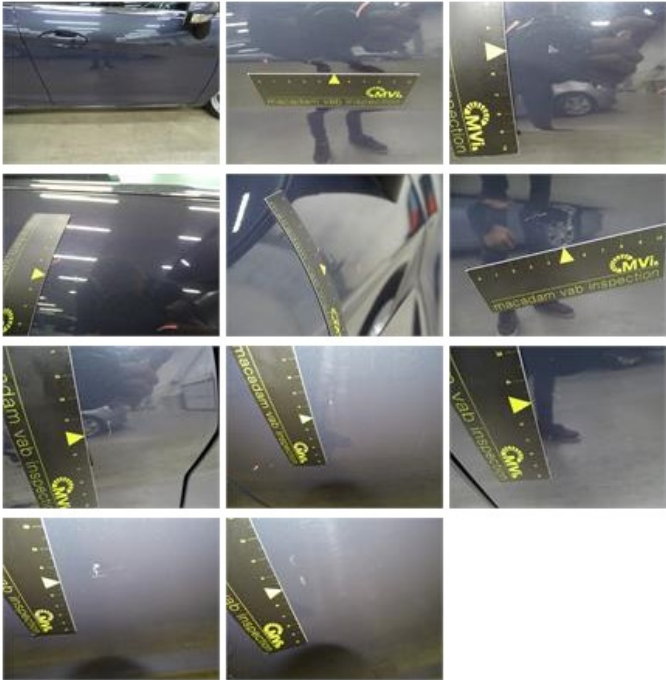
| Door F R, Dent(s) and scratch(es), LI - Repair and paint (complete) | 254,68 |

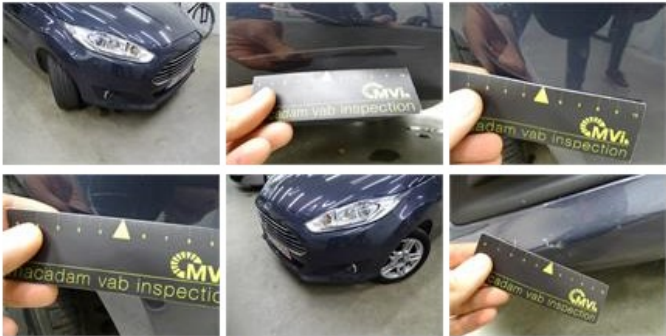
| Bumper F, Scratch(es), LI - Repair and paint (complete) | 169,44 |

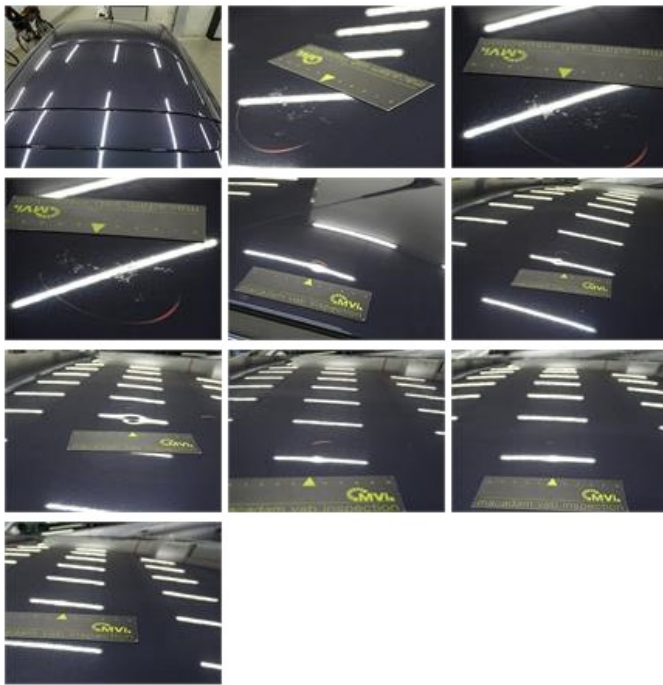
| Roof, Chemical polution, LI - Repair and paint (complete) | 433,20 |
