**BMW 3 TOURING: 1KSD720**

| Vinnumber: | <b>WBA3K110X0F839806</b> | Versionname: | <b>2.0 318D (100KW) TOURING</b> |

**Limited Technical Inspection**

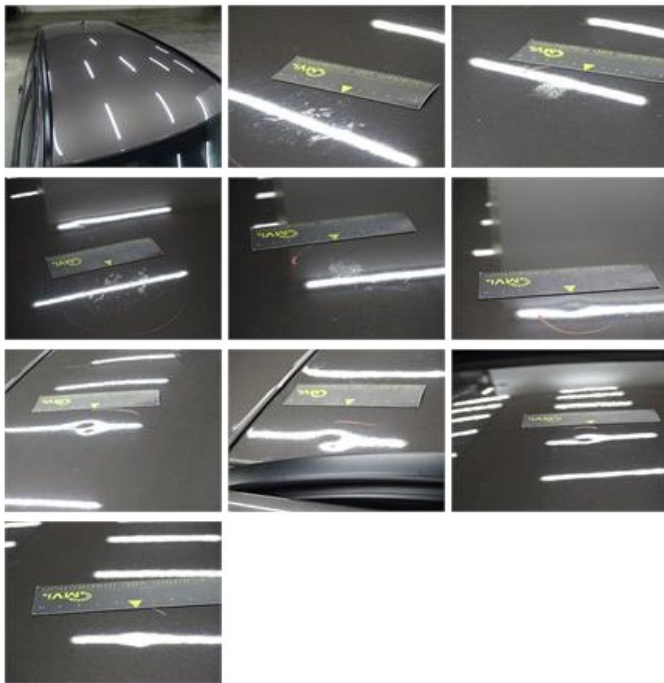
| Roof, Chemical polution, LI - Repair and paint (complete) | 529,50 |

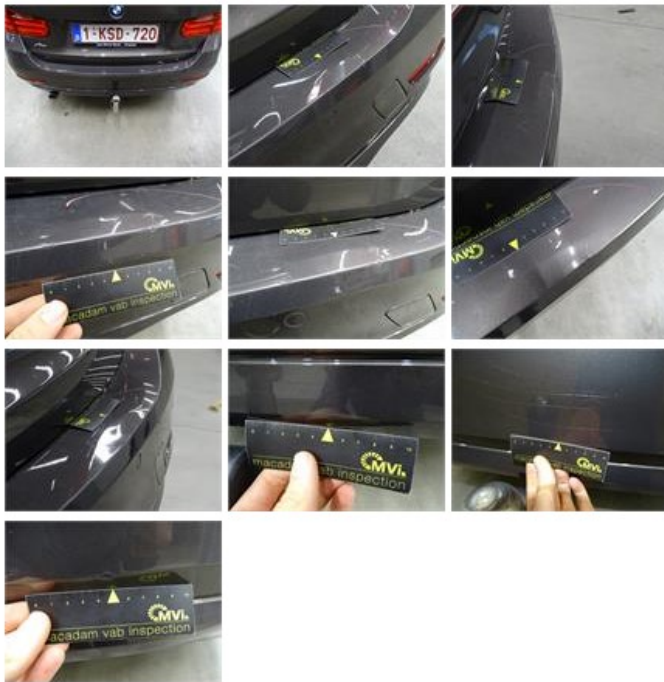
| Bumper R, Dent(s) and scratch(es), LI - Repair and paint (complete) | 211,80 |

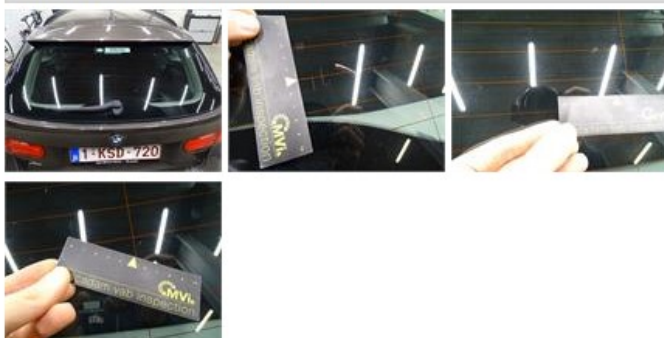
| Rear window, Scratch(es), Acceptable | 0,00 |

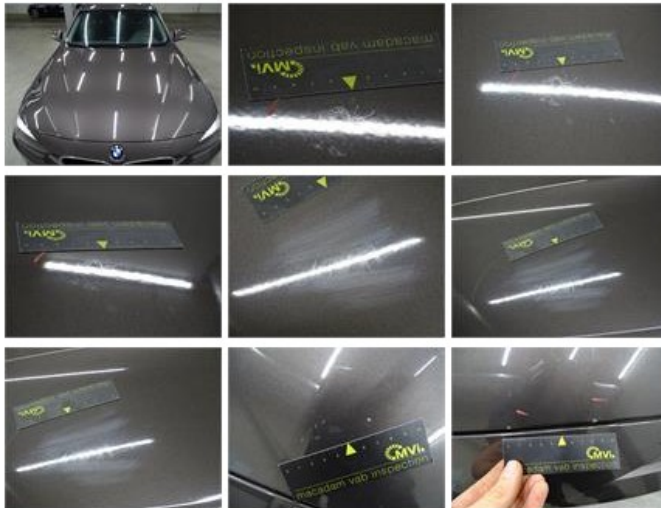
Bonnet, Chemical polution, LI - Repair and paint (complete)

290,08
