**BMW 2 Active Tourer: 1HYE170**

**Limited Technical Inspection**

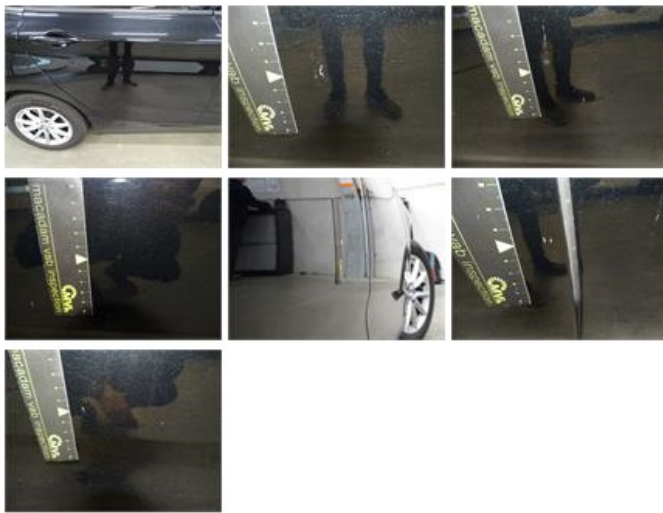
| Door R R, Dent(s) and scratch(es), LI - Repair and paint (complete) | | <b>318,35</b> |

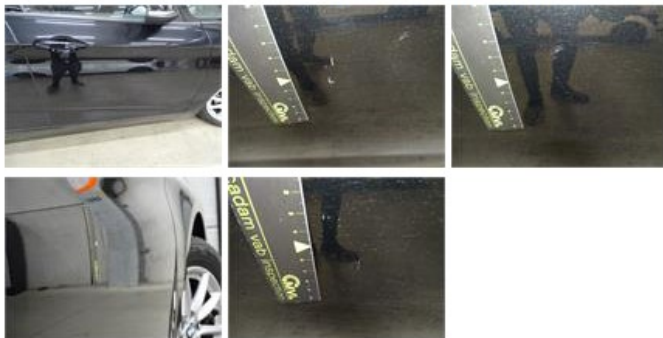
Door F R, Dent(s) and scratch(es), LI - Repair and paint (complete)

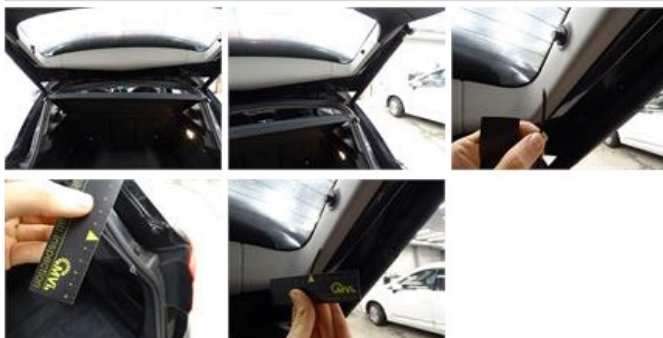
Boot cover, Broken, E - Replace

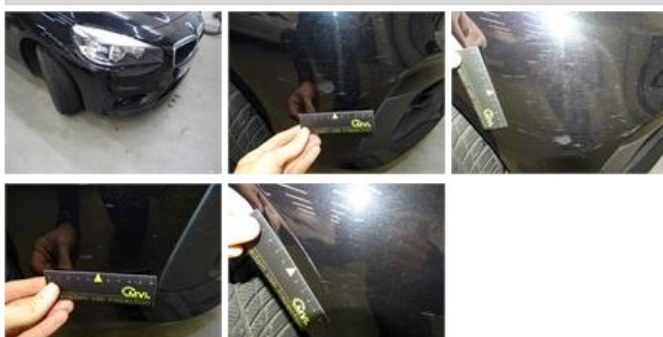
Bumper F, Scratch(es), LI - Repair and paint (complete)

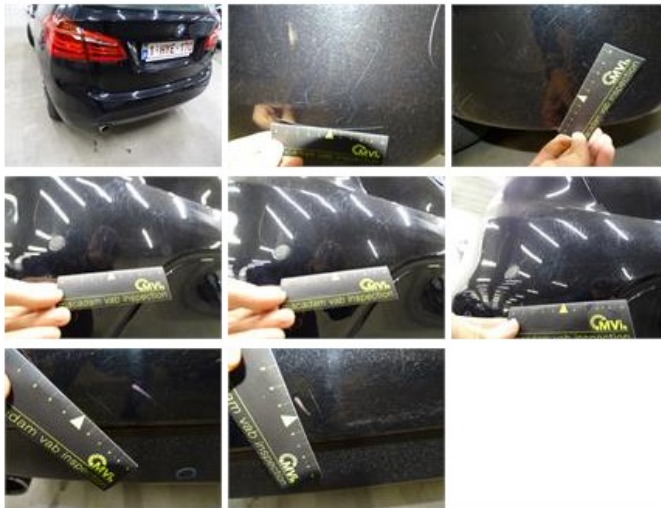
Bumper R, Scratch(es), LI - Repair and paint (complete)

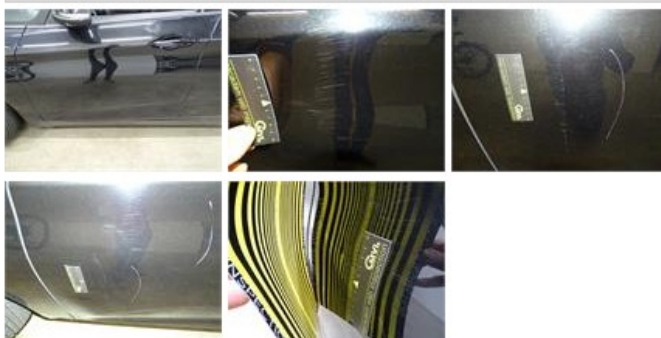
Door F L, Dent(s) and scratch(es), LI - Repair and paint (complete)
