**OPEL INSIGNIA SPORTS TOURER: 1PDD381**

| Vinnumber: | <b>W0LGT8E30G1090647</b> | Versionname: | <b>1.6 CDTI ECOFLEX 100KW S/S COSMO</b> |

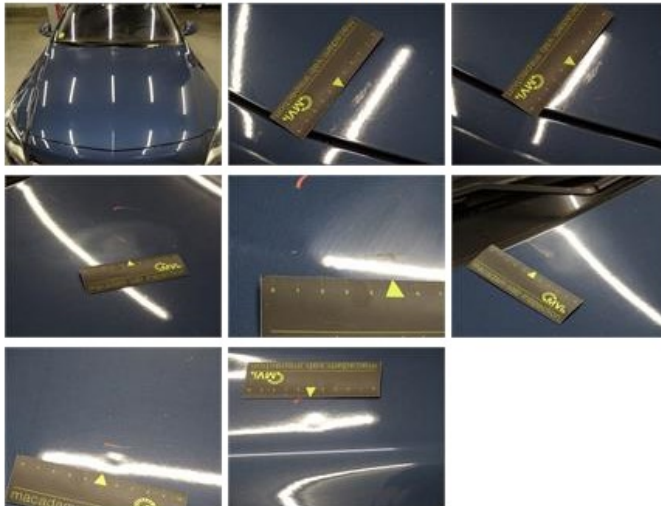
Bonnet, Chemical polution, LI - Repair and paint (complete)

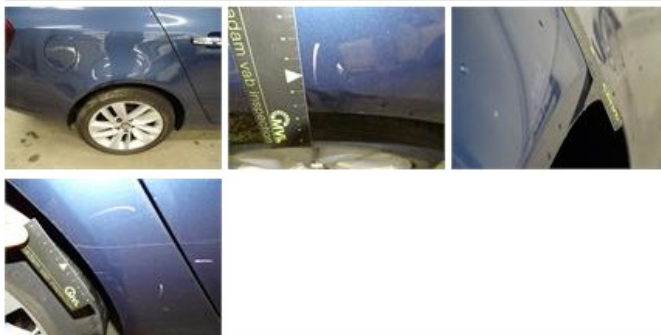
Wing R R, Dent(s) and scratch(es), LI - Repair and paint (complete)

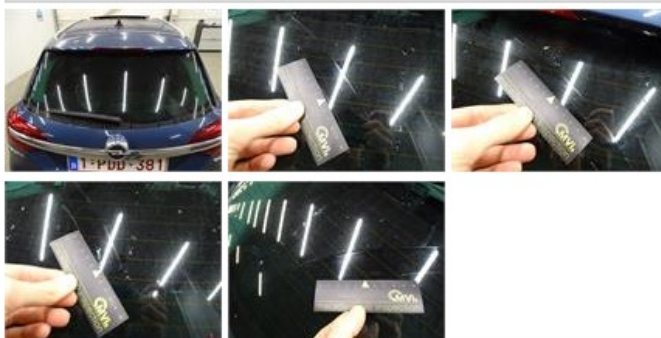
Rear window, Scratch(es), E - Replace

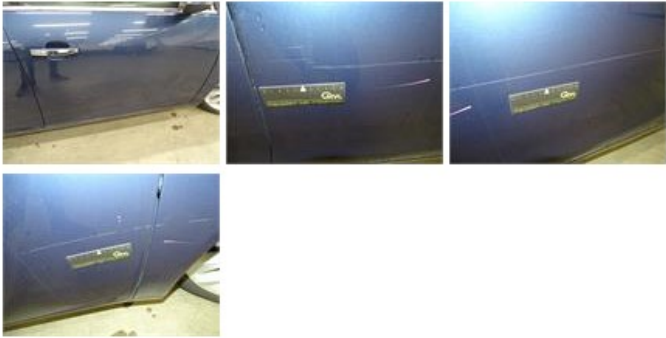
| Door F R, Scratch(es), LI - Repair and paint (complete) | | 318,35 |

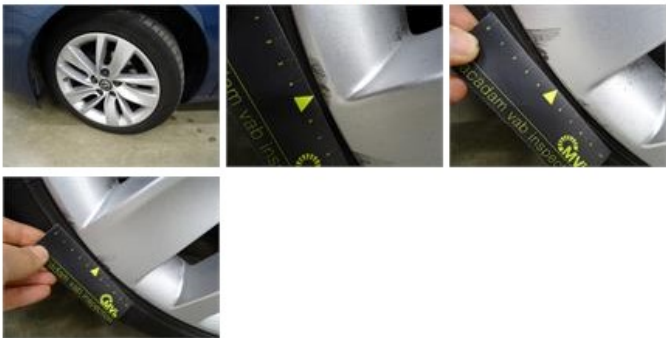
| Alloy rim F L, Scratch(es), LI - Repair and paint (complete) | | 95,00 |

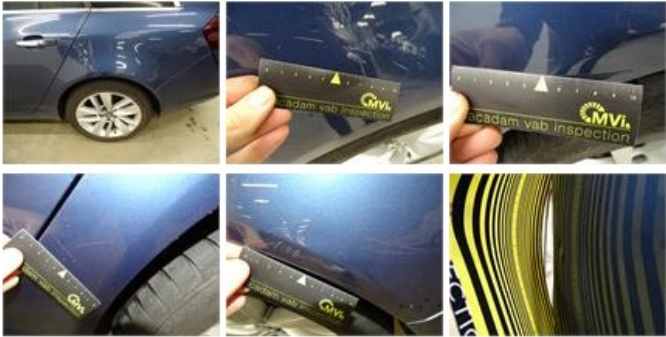
| Wing R L, Dent(s) and scratch(es), LI - Repair and paint (complete) | | 308,20 |

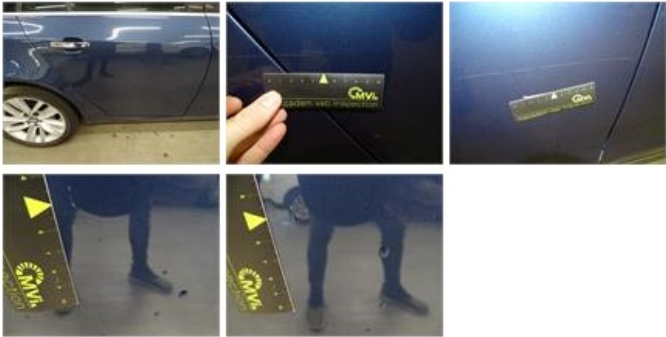
| Door R R, Scratch(es), LI - Repair and paint (complete) | | 0,00 |

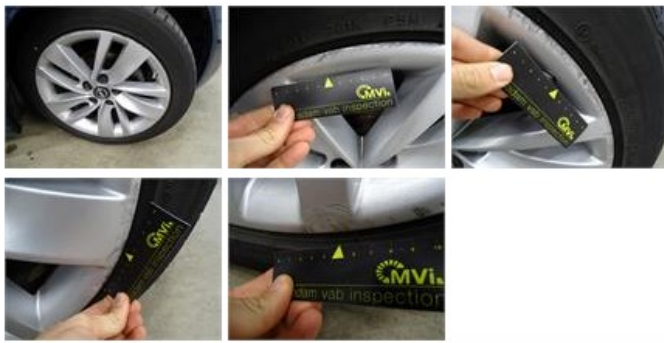
| Alloy rim F R, Scratch(es), LI - Repair and paint (complete) | | 95,00 |
