**PEUGEOT 5008: XC8622**

**Limited Technical Inspection**

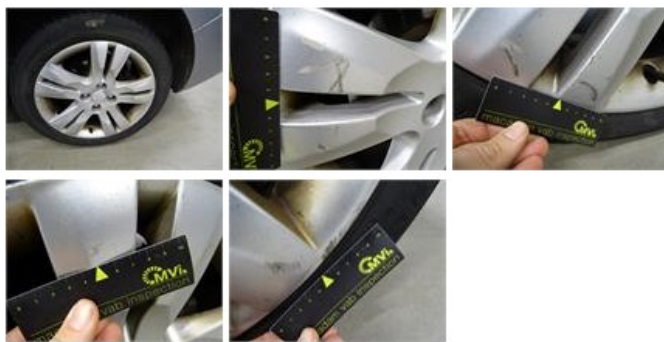
| Alloy rim R L, Scratch(es), LI - Repair and paint (complete) | <b>95,00</b> |

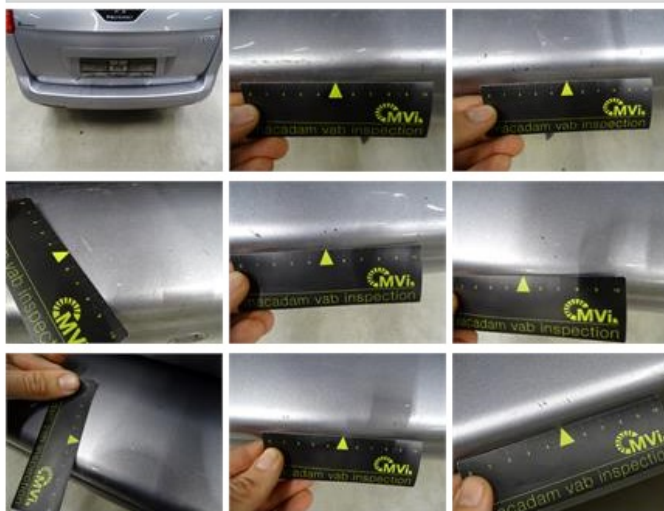
Bumper R, Scratch(es), LI - Repair and paint (complete)

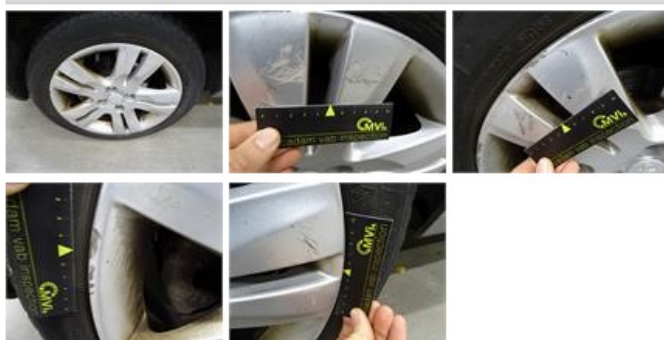
Alloy rim R R, Scratch(es), LI - Repair and paint (complete)

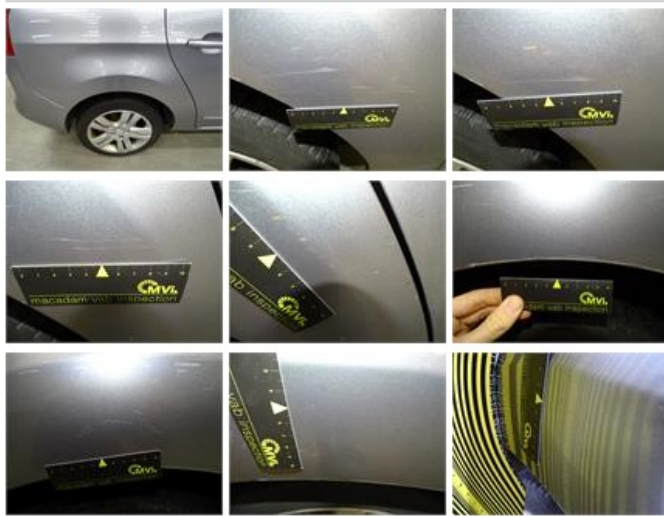
Wing R R, Dent(s) and scratch(es), LI - Repair and paint (complete)

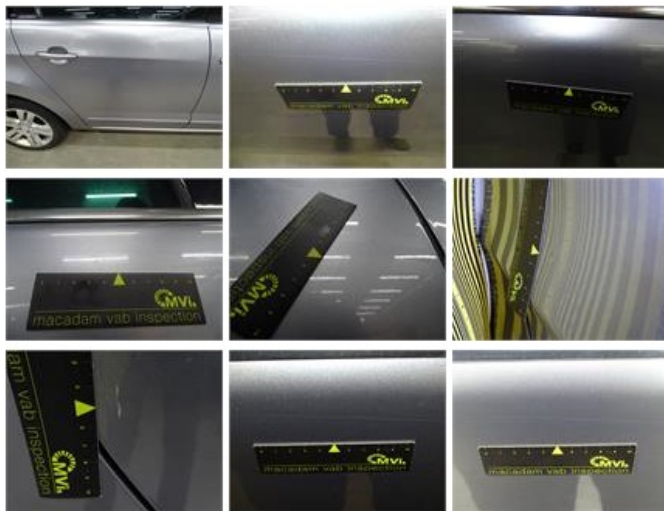
Door R R, Dent(s) and scratch(es), LI - Repair and paint (complete)

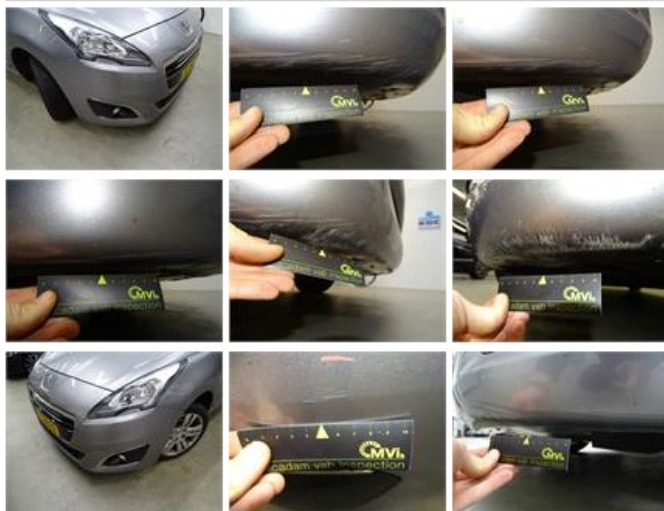
Bumper F, Scratch(es), LI - Repair and paint (complete)

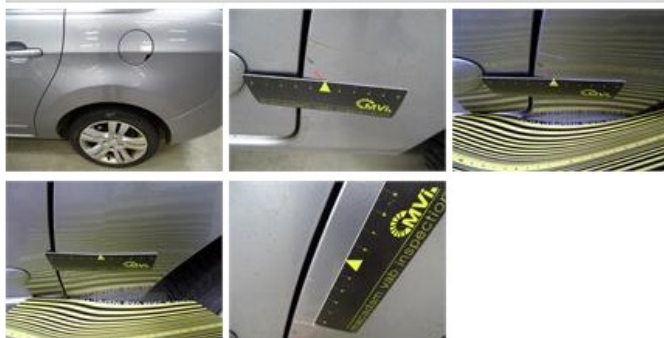
Wing R L, Dent(s) and scratch(es), LI - Repair and paint (complete)

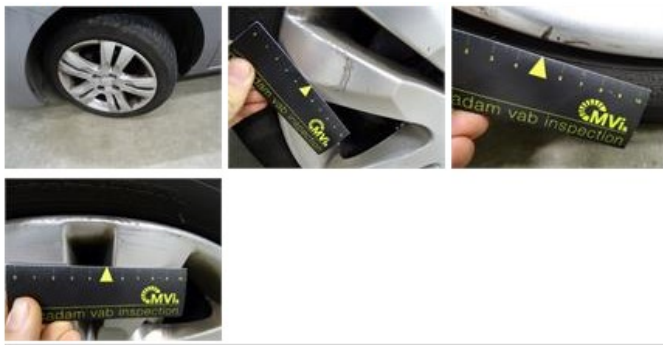
Alloy rim F L, Scratch(es), LI - Repair and paint (complete)

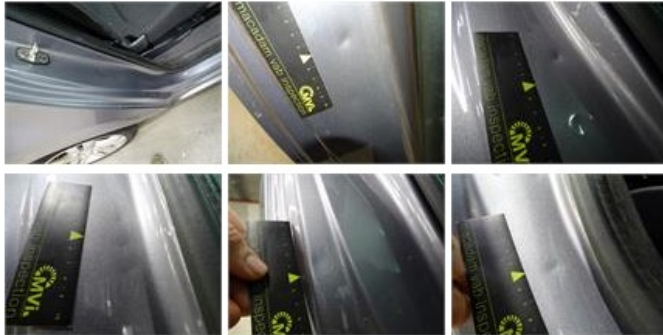
Rocker panel inner R R, Dent(s), LI - Repair and paint (complete)

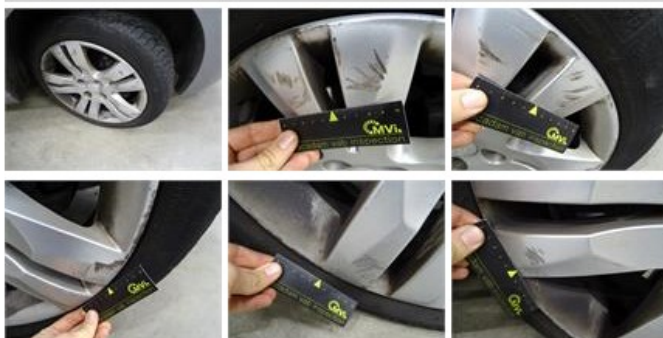
Alloy rim F R, Scratch(es), LI - Repair and paint (complete)
