| VOLVO V40: 1FGZ761 | | | |
| Vinnumber: | YV1MV8481E2084929 | Versionname: | V40 D2 Base 115PK |

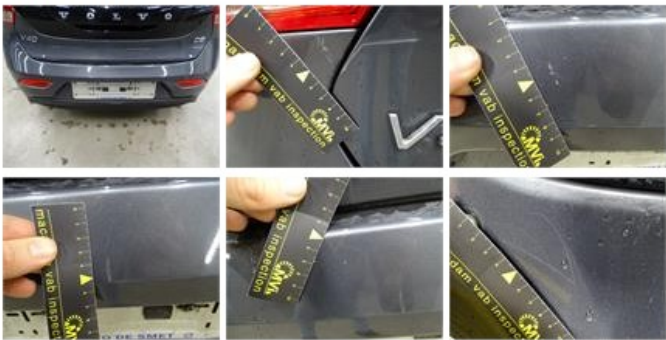
| Bumper R, Scratch(es), LI - Repair and paint (complete) | 211,80 |

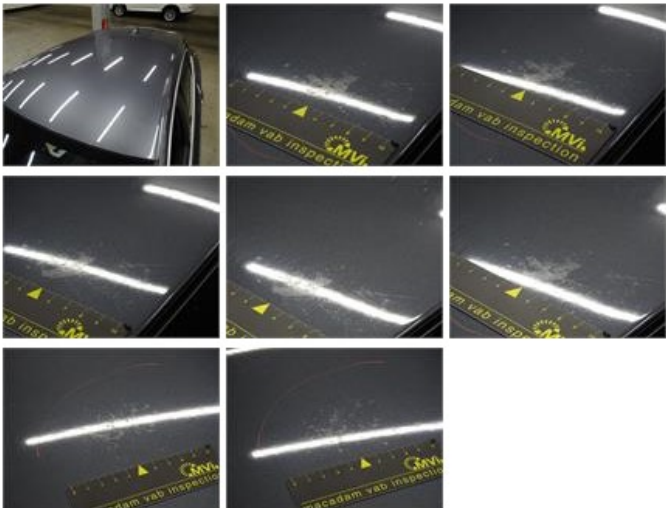
| Roof, Chemical polution, LI - Repair and paint (complete) | 481,50 |

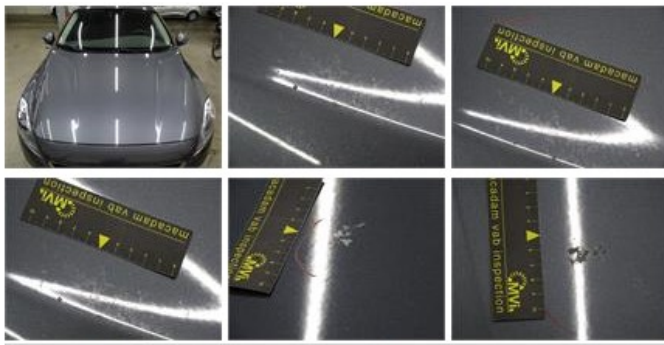
| Bonnet, Chemical polution, LI - Repair and paint (complete) | 290,08 |

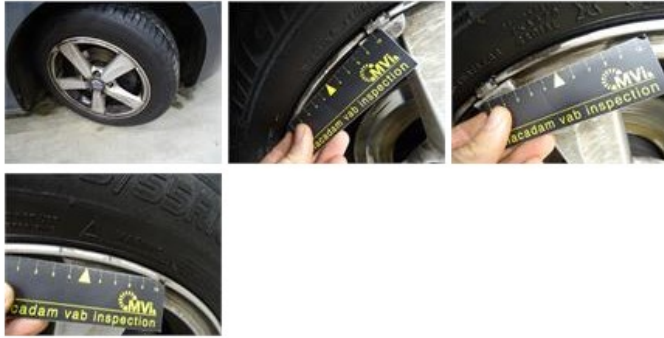
Alloy rim F R, Scratch(es), LI - Repair and paint (complete)

95,00
