**BMW 1 HATCH: 1LNY607**

| Vinnumber: | <b>WBA1S510605A84399</b> | Versionname: | <b>2.0 118D (100KW)</b> |

**Limited Technical Inspection**

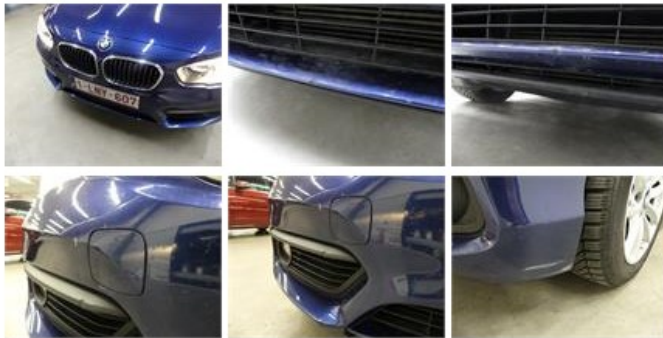
| Bumper F, Dent(s) and scratch(es), LI - Repair and paint (complete) | 211,80 |

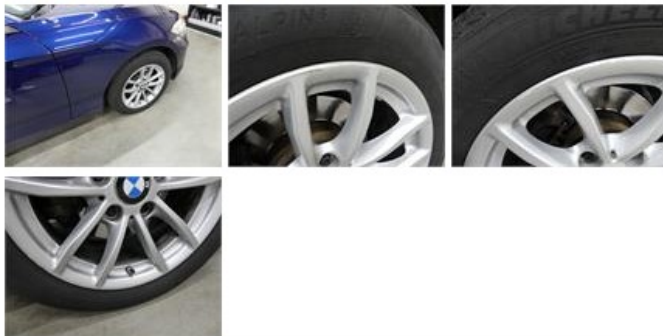
| Alloy rim F R, Scratch(es), LI - Repair and paint (complete) | 95,00 |

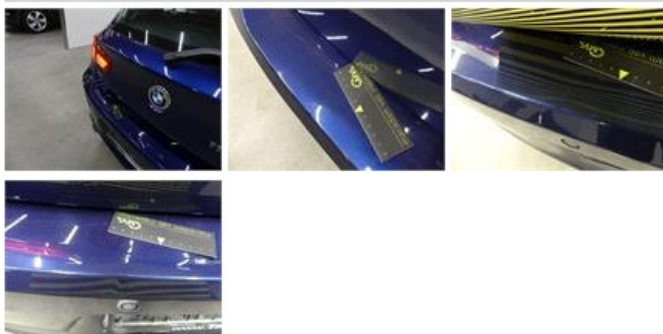
| Bumper R, Dent(s) and scratch(es), LI - Repair and paint (complete) | 259,80 |
