FORD S-MAX: 1LVF566

| Vinnumber: | WF0JXXWPCJFM55587 | Versionname: | 2.0 TDCI 110KW S/S BUSINESS ED+ |

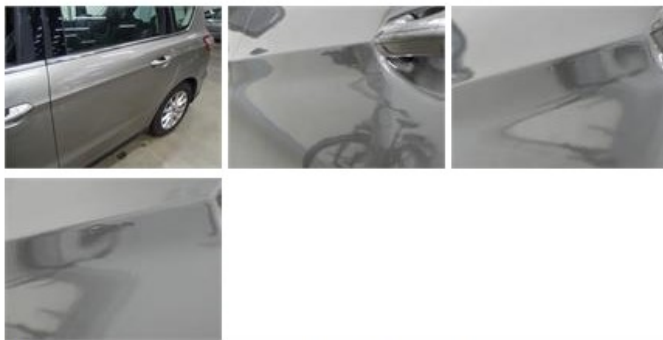
Door R L, Bad repair, Acceptable

0,00

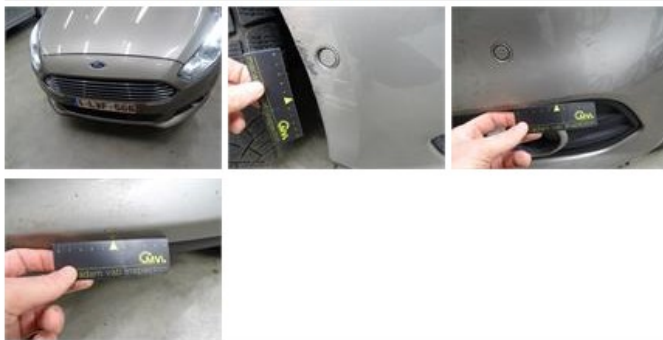
Bumper F, Scratch(es), LI - Repair and paint (complete)

254,16

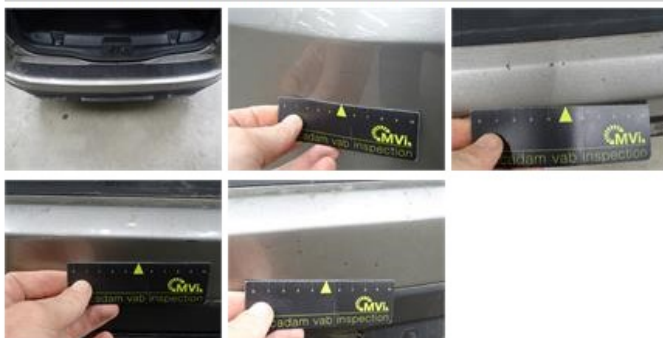
Bumper R, Scratch(es), LI - Repair and paint (complete)

254,16
