| VOLVO V70: 1ELF579 | | | |
| Vinnnumber: | <b>YV18W84A1D1267930</b> | Versionname: | <b>V70 D2 Kinetic St/St 115PK</b> |

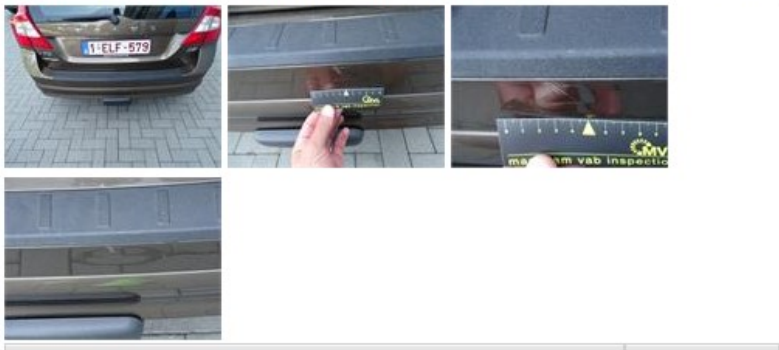
| Assistance equipment | |
|---|---|
| Bumper R, Bump(s) and scratch(es), LI - Repair and paint (complete) | <b>254,16</b> |
