| SEAT Alhambra: 1HFL602 | | | | |
| Vinnnumber: | VSSZZZ7NZEVS13880 | Versionname: | ALHAMBRA | |

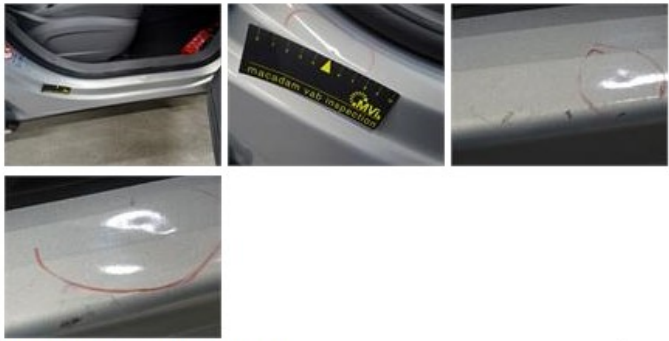
| SEAT Alhambra: 1HFL602 | | | | |
|---|---|---|---|---|
| Rocker panel inner F R, Dent(s), LI - Repair and paint (complete) | | 115,56 | | |
