VOLKSWAGEN CADDY: 1JNL545

Limited Technical Inspection

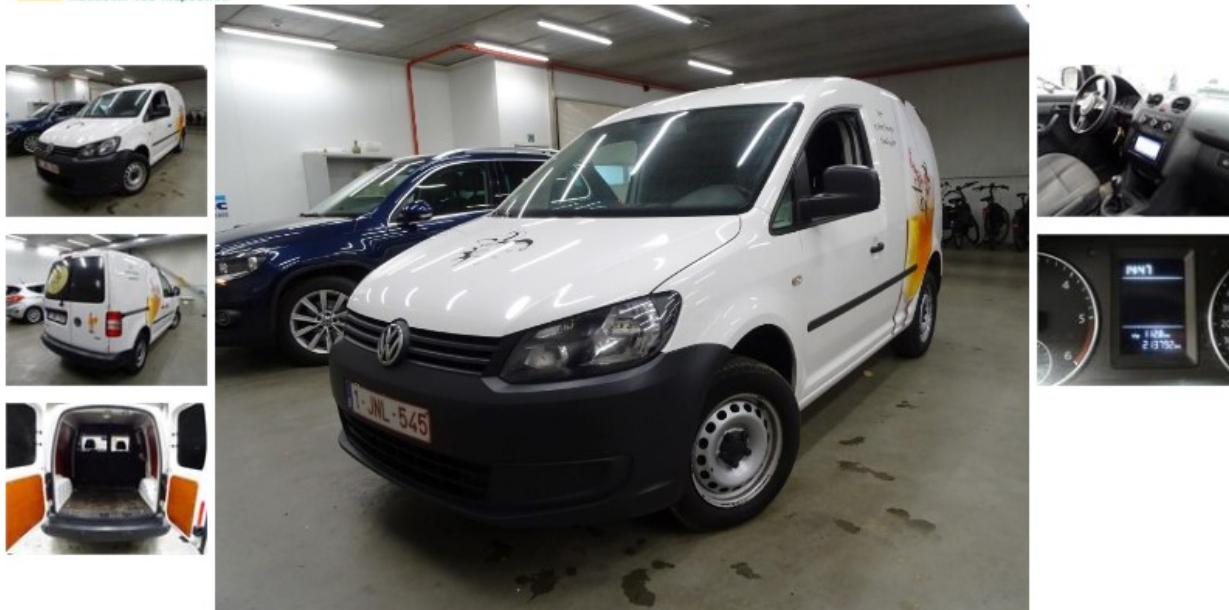
Vinnumber:	WV1ZZZ2KZEX127950	Versionname:	1.6 TDI 75KW VAN
First Registrationdate:	26/01/2015	Fiscalpower:	
Expertise Mileage:	213792	Power Kw:	75
Bodytype:		Body color:	White
Gearbox:	MAN 5 VIT	Paint type:	Opaque
Transmission:	Front	Rims summer:	Steel
Fueltype:	Diesel	Oil level:	OK
Maintenance:	OK	Parking lot:	3226
Battery functioning:	Yes		
Number of doors:	5		
Number of seats:	2		
Number head rests:	2		
Rims summer:	Steel		
Category:	Light Commercial Vehicle		
Oil level:	OK		
Registration Certificate Car (BE):	Yes
